**MUAYENE VE DENEY RAPORU**  
**TEST REPORT**

**Numunenin Tanımı** : 566334,ÇİFT CAMLI CAM-CAMA BÖLME DUVAR SİSTEMİ, KASA WALL , PLUS , - , - , 12,40  
(No,Cins, Marka, Tip, Tür, Model vb.) metrekaare

**Sample Description**(No,Type,Mark,Model etc.) 566334,KASA Wall PLUS series, Double Glazed, Glass To Glass Partition Wall System,KASA WALL,PLUS,,12,40 square meter

**Uygulanan Standard / Metod** : TS EN ISO 10140-2:2013-06 , TS EN ISO 717-1:2013-06  
**Applied Standard/Method** TS EN ISO 10140-2:2013-06 , TS EN ISO 717-1:2013-06

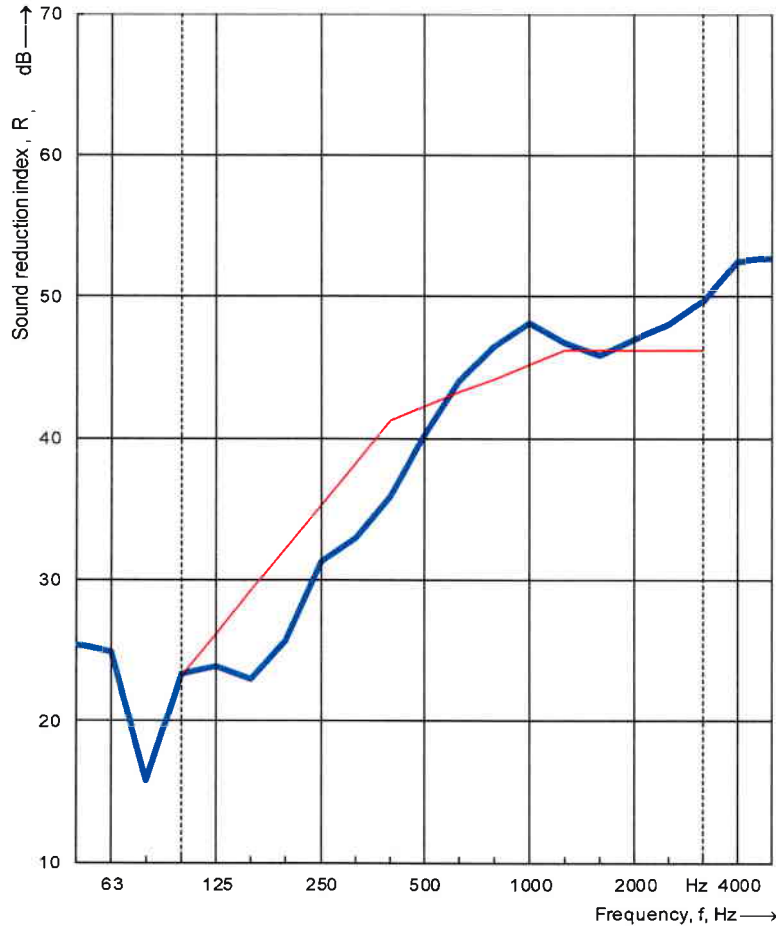
### Sound reduction index according to ISO 10140-2

Frequency f [Hz]	R 1/3 octave [dB]
50	25,4
63	24,9
80	15,8
100	23,3
125	23,9
160	23,0
200	25,7
250	31,3
315	32,9
400	35,9
500	40,2
630	44,0
800	46,4
1000	48,1
1250	46,7
1600	45,8
2000	47,0
2500	48,0
3150	49,7
4000	52,5
5000	52,7

Rating according to ISO 717-1

$R_w (C; C_{tr}) = 42,2 (-3 ; -7) \text{ dB}$

$C_{50-3150} = -3 \text{ dB}$   $C_{50-5000} = -2 \text{ dB}$   $C_{100-5000} = -2 \text{ dB}$   
 $C_{tr,50-3150} = -9 \text{ dB}$   $C_{tr,50-5000} = -9 \text{ dB}$   $C_{tr,100-5000} = -7 \text{ dB}$

$$R_w(C;Ctr) = 42,2 (-3 ; -7) \text{ dB}$$

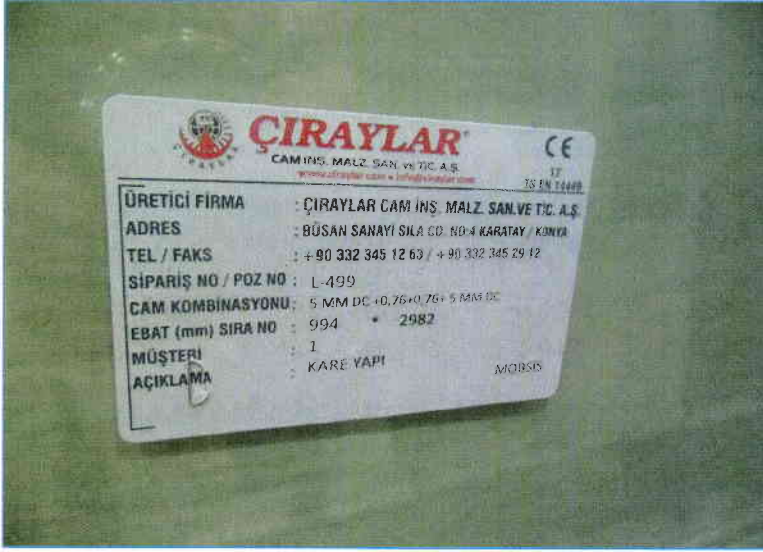
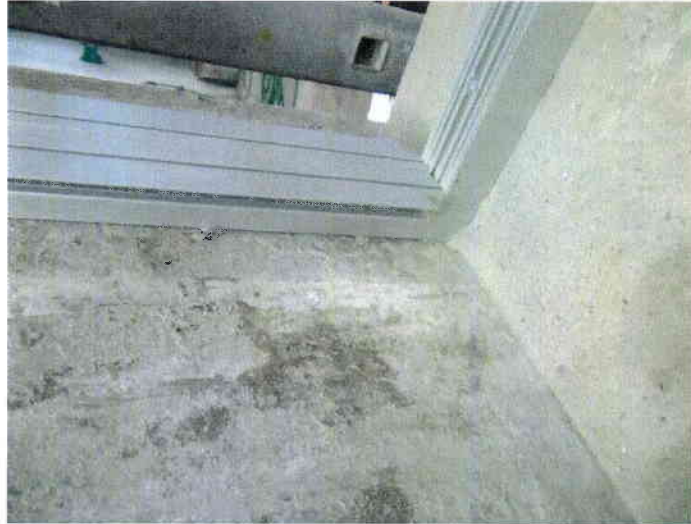
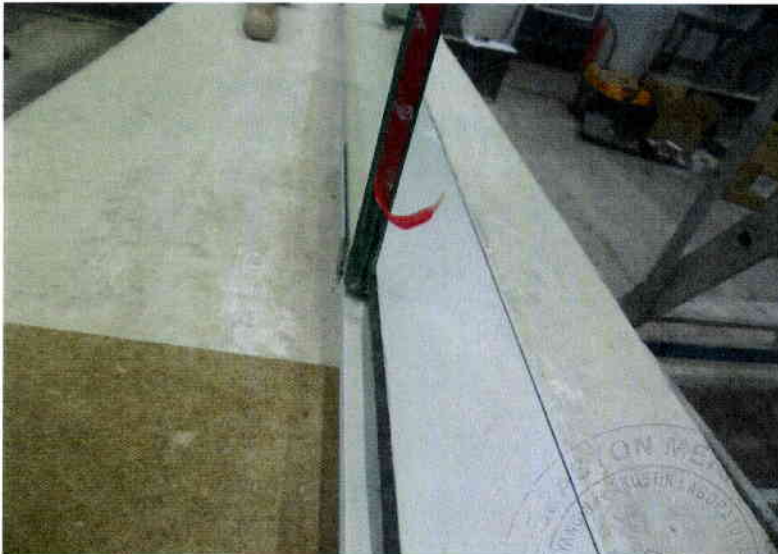
**PHOTOS FOR TEST SPECIMEN IN SEVERAL STAGES**

**Description of the product:** Double glazed glass partition wall system with approximately 75 mm total system thick that is constituted with various types of aluminium profiles, gaskets, 5mm+1,52mm(0,76+0,76) PVB+5mm mm thick laminated glass and 50mm gap between glasses.

- Test frame was chosen according to TS EN ISO 10140-5. Test frame has dimensions of 4060mm width and 3060mm height.
- Test specimen was installed in to the frame by client in a similar manner to the actual construction practice.
- System was constructed in the laboratory then it was mounted in to the frame.
- The ratio of the niche depths on either side of the test element is approximately 2:1.
- Installation of the frame between the test rooms was carried out by the laboratory.

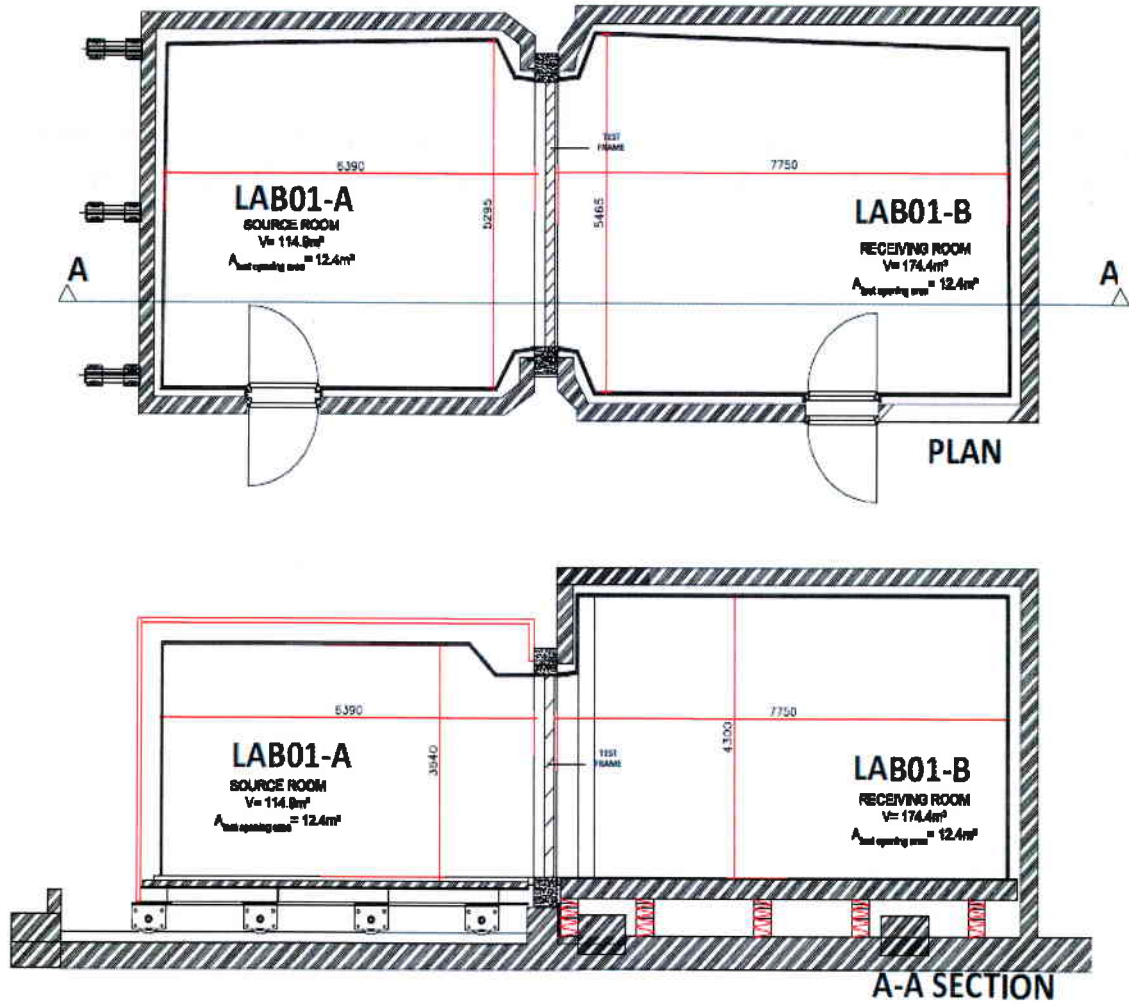
FIGURES REGARDING THE TEST FACILITY

<b>Volume of source room</b>	<b>114,9m<sup>3</sup></b>
<b>Volume of receiving room</b>	<b>174,4m<sup>3</sup></b>
<b>Test opening</b>	<b>12,4m<sup>2</sup></b>

- Two horizontally adjacent rooms, one of which is the source and the other is receiving, were used for tests.
- Test specimen was installed into the test opening as defined in clause 3.2 of this report.
- Loud speakers and microphones were placed at locations, which were determined previously.
- Microphone verifications were made before and after measurements.
- Sound pressure level measurements were carried out with mechanized microphone, during 60s. During the measurements, the time of rotating boom whole movement period is equal to 60 s.
- At the receiving room, 12 measurements were conducted for each 1/3 octave band frequencies to obtain reverberation time according to TS EN ISO 3382.
- Background noise measurements were conducted at receiving room for making correction on the sound pressure levels if necessary.

Client: Kare Yapı Sistemleri İnşaat Ltd. Şti. Date of test: 24.12.2019  
Test room identification: Two horizontally adjacent rooms, one of them is source room has 114,9 m<sup>3</sup> volume and the other one is receiving room has 174,4 m<sup>3</sup> volume, were used for tests. Diffusers were placed in rooms in order to provide diffuse sound field. Rooms are comply with all requirements of TS EN ISO 10140-2 and TS EN ISO 10140-5 standards. Figures regarding the rooms were presented in the report.
